**RE: City of Gresham File Number SD/MIS 20-26000343 (MPLAN 21-00652)
Veranda Master Plan and Subdivision**

AKS Representative Site Photographs, August 4, 2023

August 3, 2023
HGSI Project No. 23-3128

**Subject: PRELIMINARY GEOTECHNICAL REPORT AND GEOLOGIC HAZARD EVALUATION
VERANDA
7928 SE 190TH DRIVE
GRESHAM, OREGON**

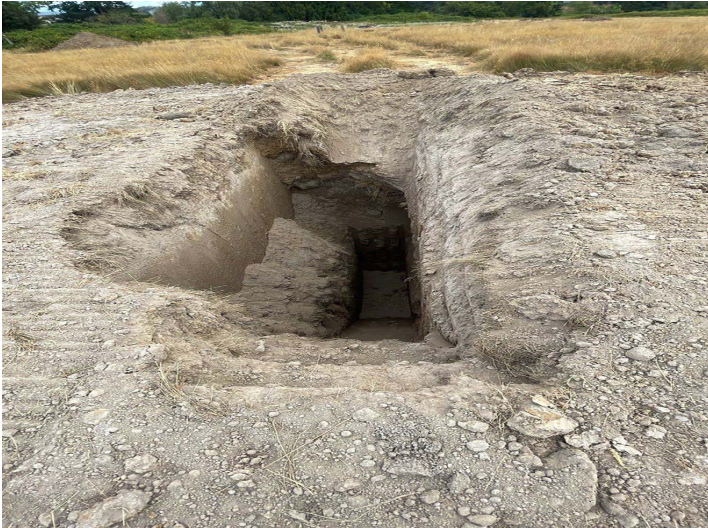
Test Pit 5 located within Wetland 1 was excavated on August 1, 2023 and was left open for a few days to allow for sufficient time for a groundwater table to stabilize into excavated test pit. I visited the site on August 4, 2023 to document whether a groundwater table had equilibrated into Test Pit 5. As shown on the attached AKS representative photo sheet, Test Pit 5 was dry on August 4, 2023 after being left open for four days. I did not observe any sidewall seeps or glistening sidewall peds (see attached AKS Photo Pages).

Photo A. View north of Hardman Geotechnical Excavator Test Pit #5.

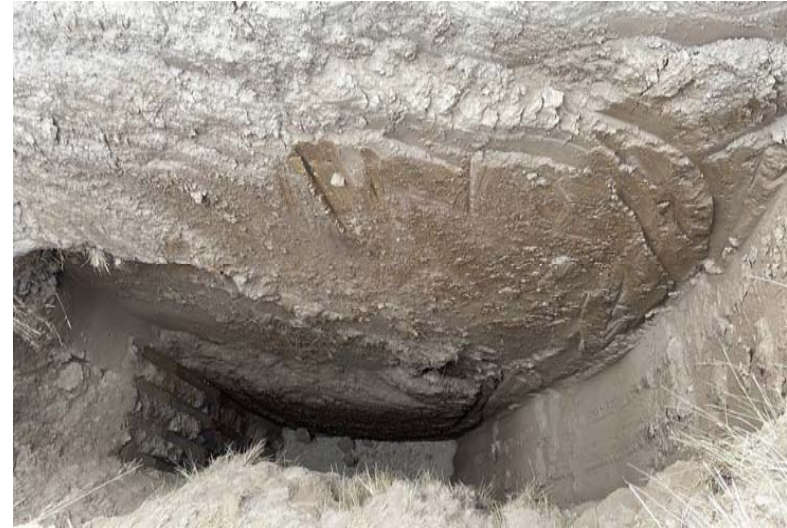
Photo B. View looking down into Hardman Geotechnical Excavator Test Pit #5.

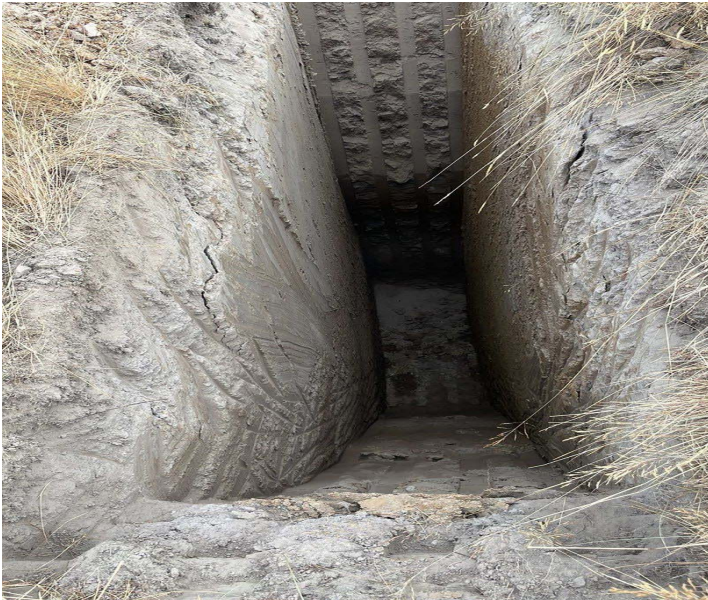
Photo C. View looking down into Hardman Geotechnical Excavator Test Pit #5.

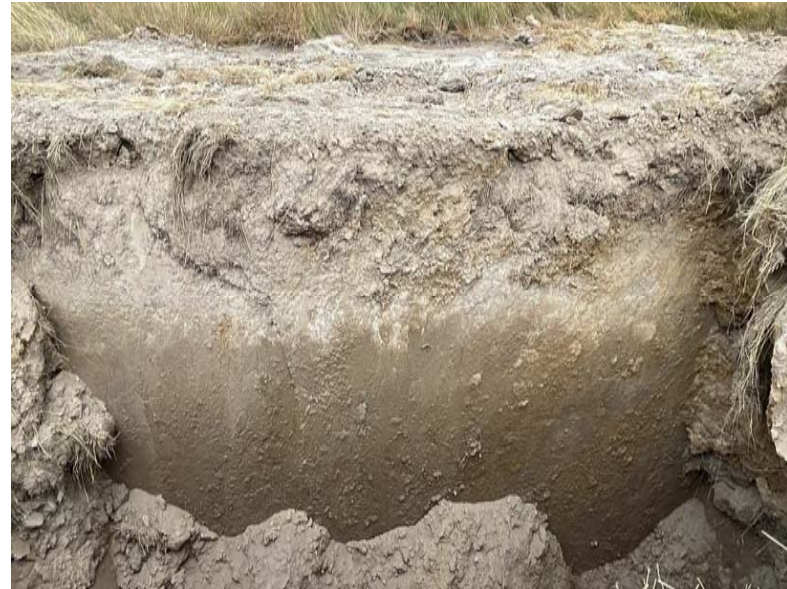
Photo D. View of Hardman Geotechnical Excavator Test Pit #5 eastern sidewall.

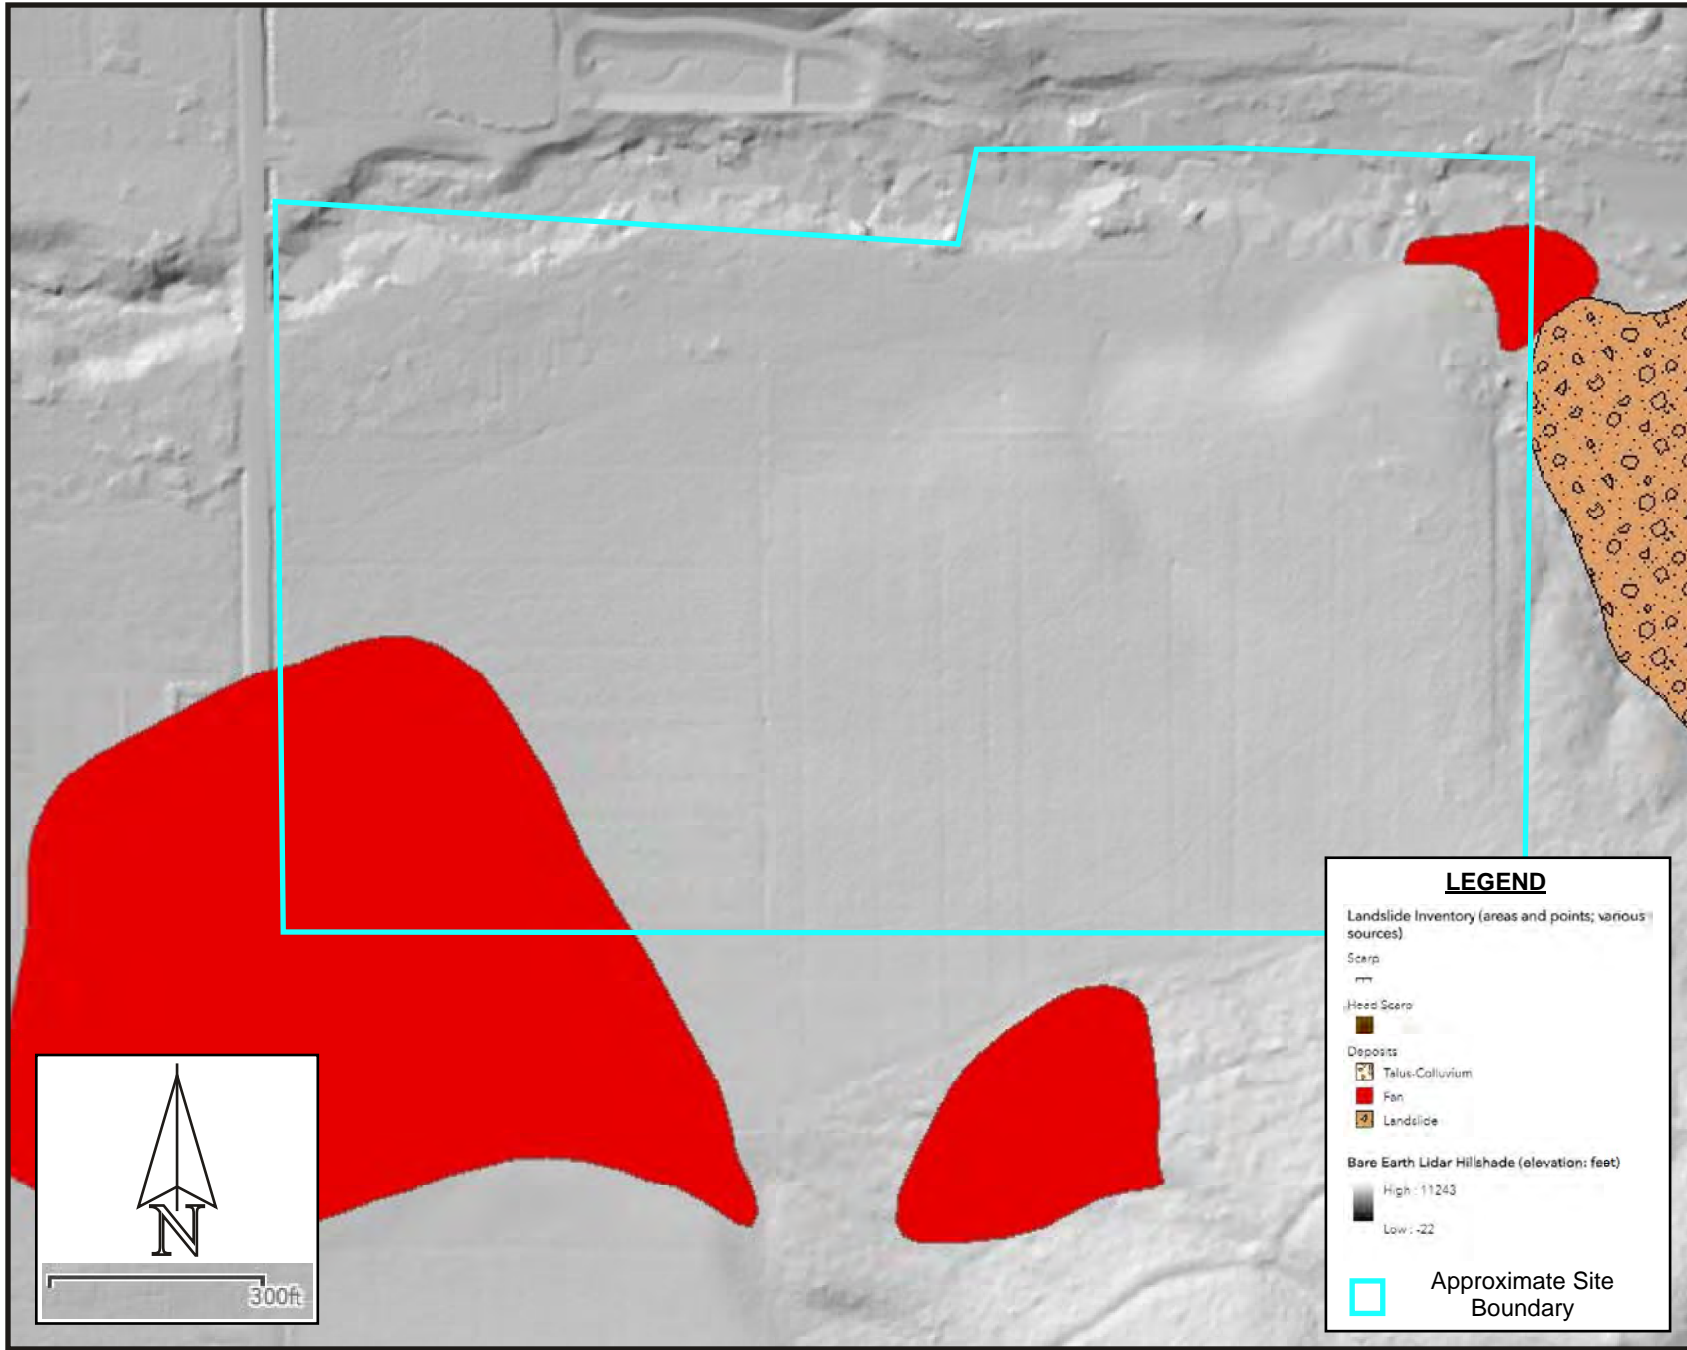
FIGURE 3a

Reconnaissance observations indicate that slope geomorphology at the site is generally smooth and uniform, consistent with stable slope conditions. No geomorphic evidence of prior slope instability (such as hummocky topography, benches or old scarps) was observed. No seeps or springs were observed on site. As shown in the bare-earth lidar mapping, Figures 3 and 3a, there are several areas mapped as being underlain

by ancient debris-flow materials. The features are mapped with Moderate (11-29%) Confidence Level, and are of prehistoric origin (older than 150 years). The presence of the ancient debris flow soils (if the mapping is correct) does not represent a geologic hazard to the site.

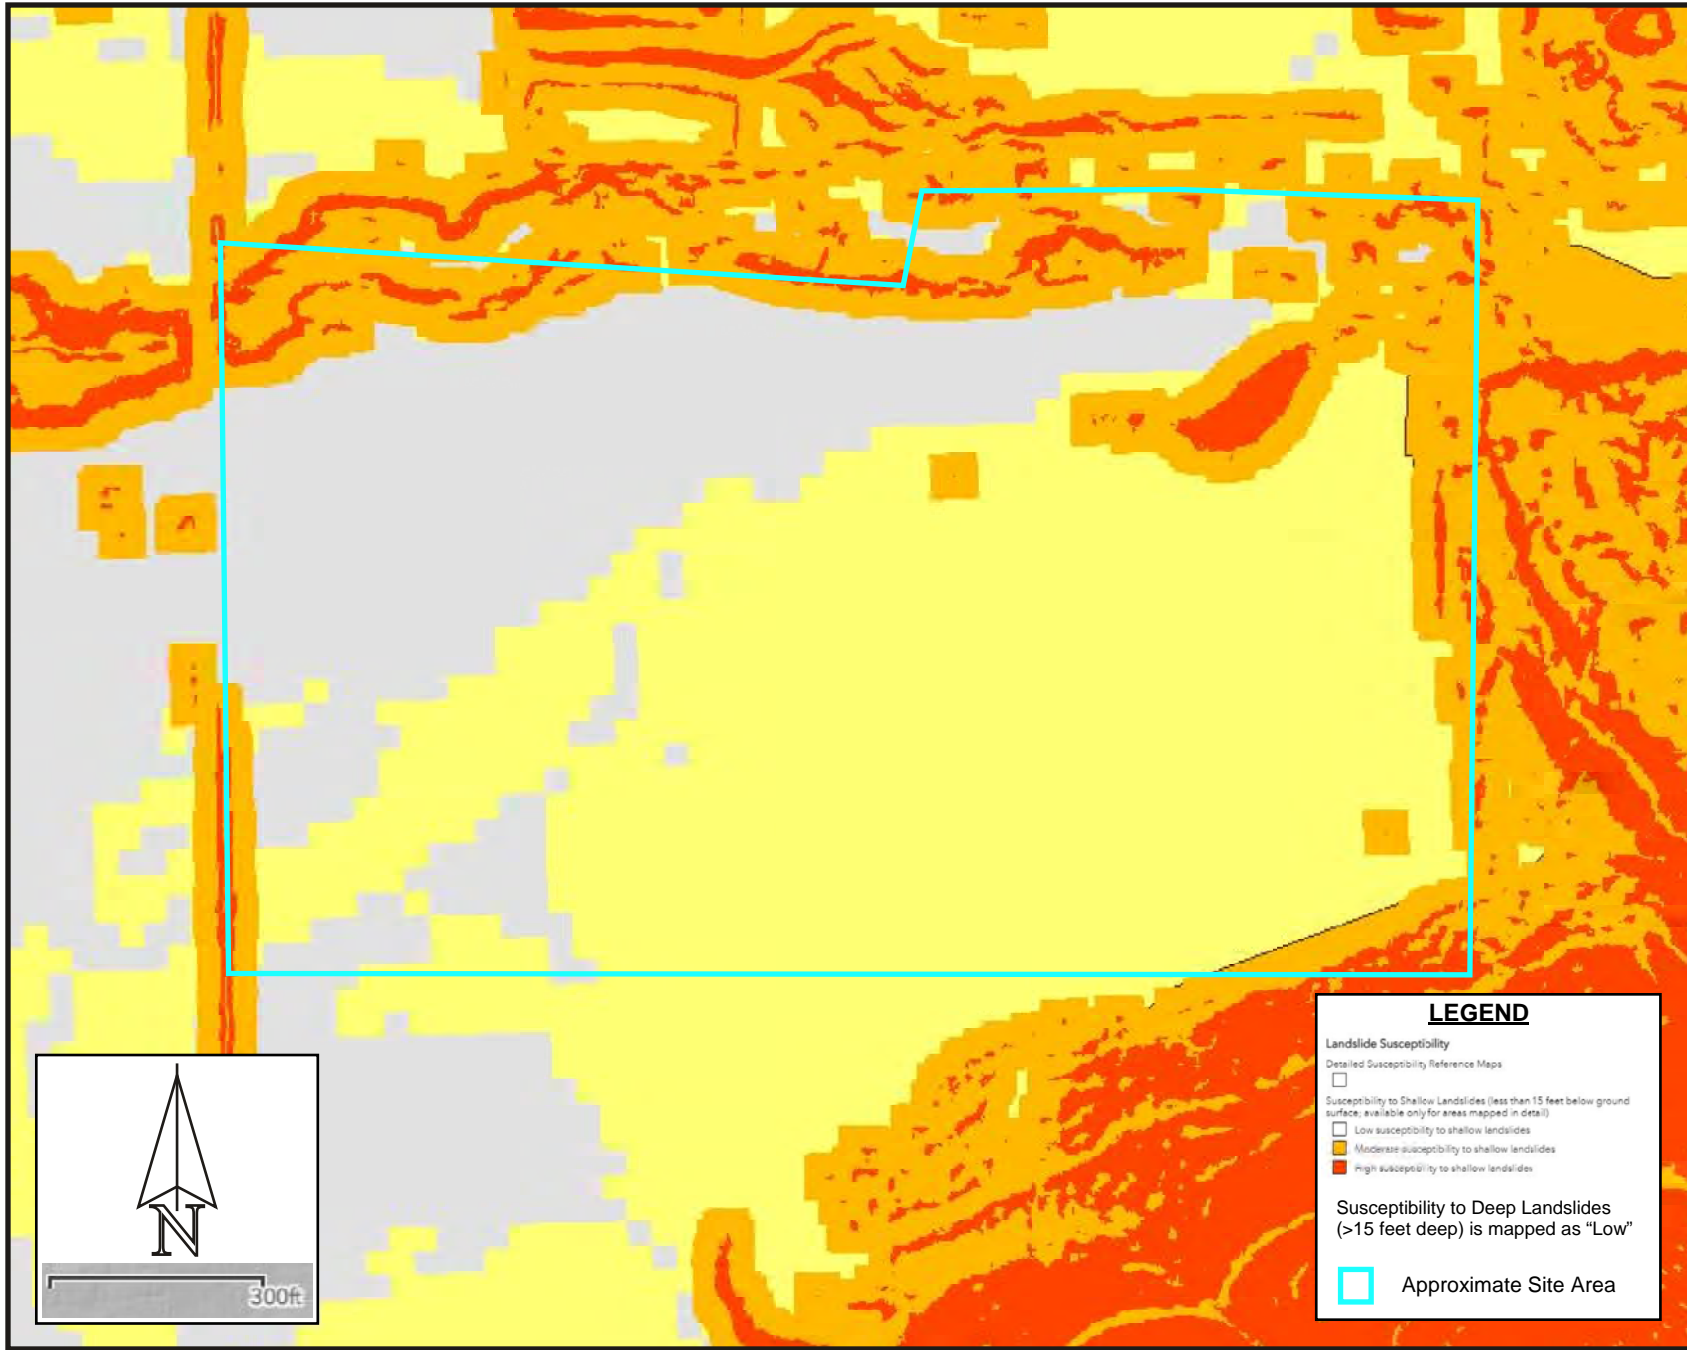
FIGURE 3b

Regional geologic mapping and the Oregon Department of Geology and Mineral Industries online landslide database (SLIDO, 2021) shows that, across much of the site, the landslide susceptibility for shallow slides is low to moderate except at the northeast portion along Kelley Creek where susceptibility is high to very high, as shown in Figure 3b. The areas of high risk for shallow sliding will be avoided by the site development plan.
