RE: Gresham/Fairview NPDES Stormwater Permit #101315
Permit Year 23, 2018 Annual Report

**National Pollutant Discharge Elimination System
Permit No. 101315
EPA Reference No. ORS108013
Permit Year 23 Annual Report
City of Gresham and City of Fairview**

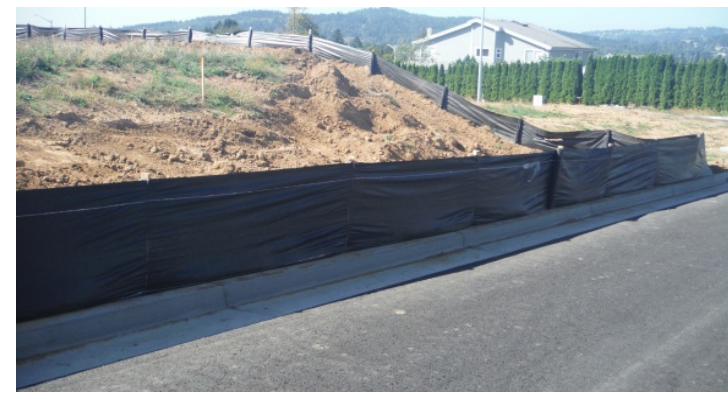
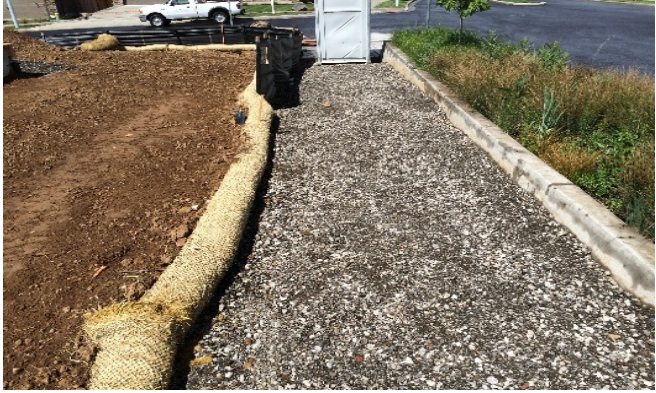
- Properly install perimeter protection (fiber roll/wattle or silt fence) to keep soil on site.

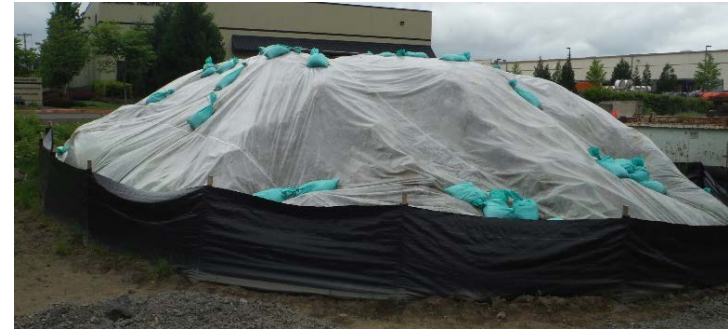
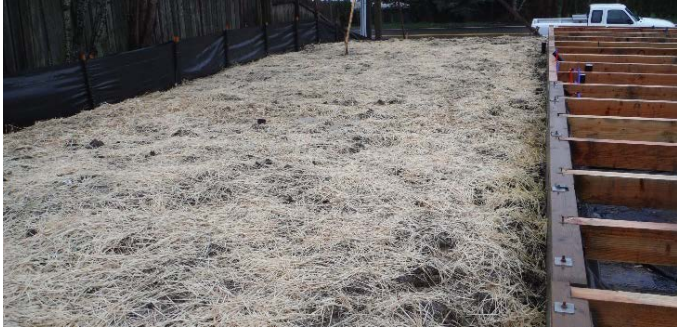
- Tarp stockpiles and protect exposed soil with straw or hydroseed to prevent runoff.

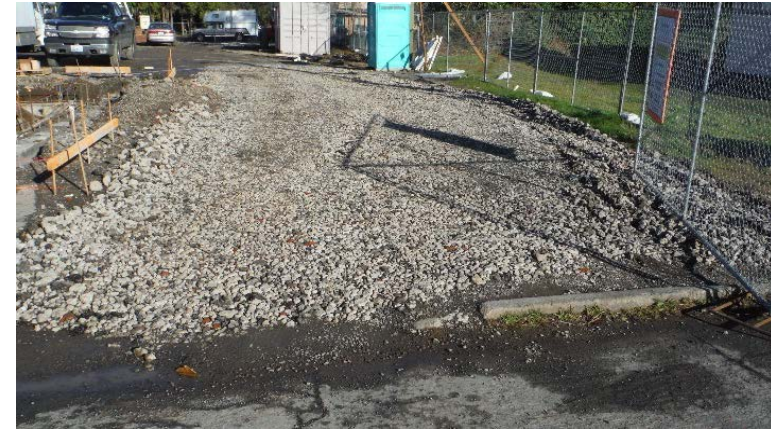
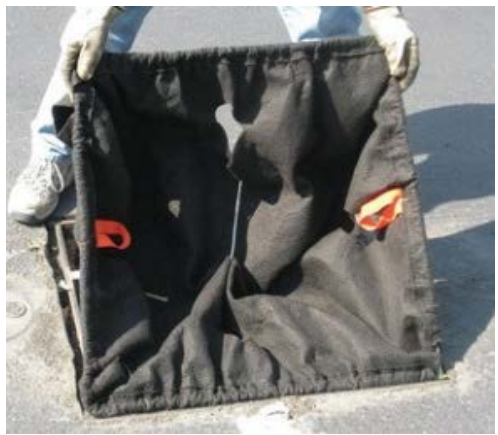
- Prevent sediment tracking into street with rocked construction entrance and protect catch basins with inserts.
