**RE: City of Gresham File Number SD/MIS 20-26000343 (MPLAN 21-00652)
Veranda Master Plan and Subdivision**

AKS Representative Site Photographs, August 4, 2023

August 3, 2023
HGSI Project No. 23-3128

**Subject: PRELIMINARY GEOTECHNICAL REPORT AND GEOLOGIC HAZARD EVALUATION
VERANDA
7928 SE 190TH DRIVE
GRESHAM, OREGON**

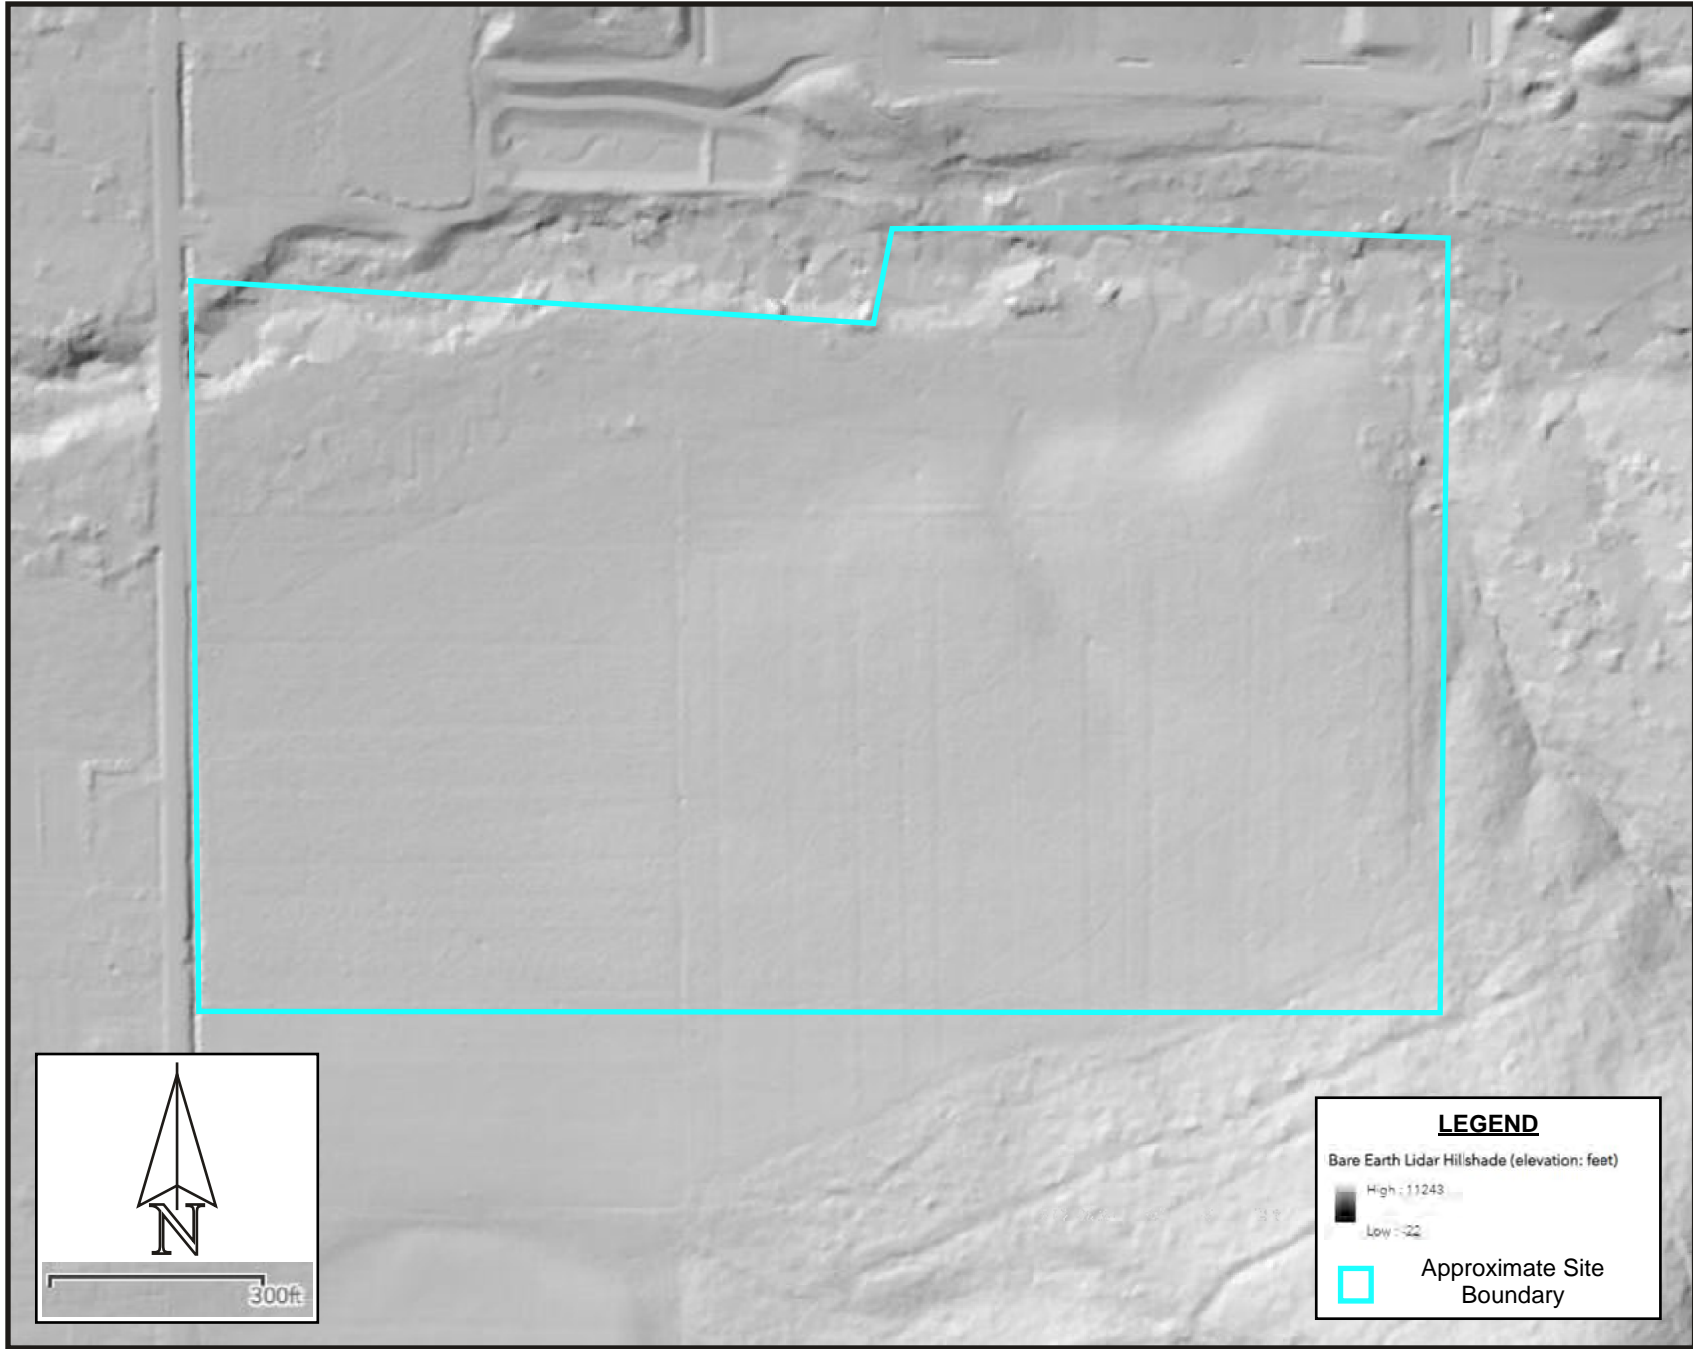
FIGURE 3

Reconnaissance observations indicate that slope geomorphology at the site is generally smooth and uniform, consistent with stable slope conditions. No geomorphic evidence of prior slope instability (such as hummocky topography, benches or old scarps) was observed. No seeps or springs were observed on site. As shown in the bare-earth lidar mapping, Figures 3 and 3a, there are several areas mapped as being underlain
